SUBJECT: VMF(N)-542 AAR ser 3-53 of 9 March 1953 with encl thereto; comments on

THIRD ENDORSEMENT on VMF(N)-542 AAR ser 3-53 of 9 Mar 1953 concerning  
F3D-2 BuNo 125843

Subj: Aircraft Accident Report, case of Captain Cameron A. MALLORY  
(b) (6) USMCR

(29) THE ACCIDENT

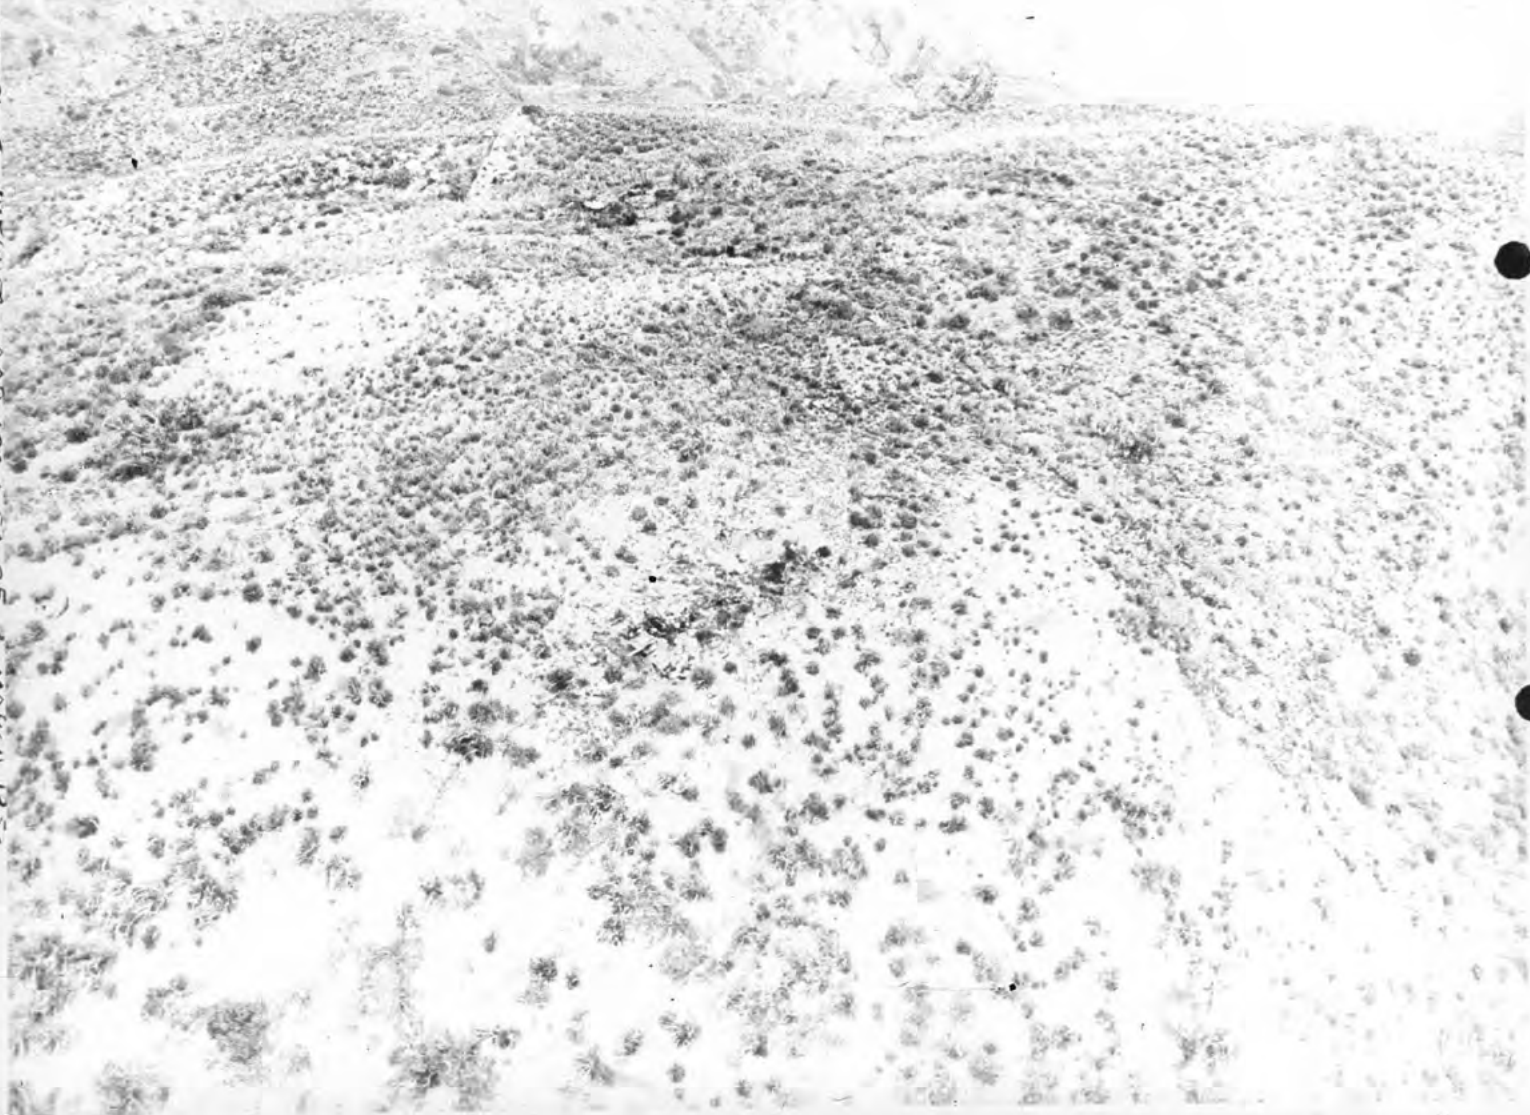
The aircraft was completely demolished. Pieces of the wreckage were generally confined a radius of 500 yards from the point of impact. Some small pieces of the aircraft were found on the opposite side of the ridge line from the point of impact, a distance of approximately 1500 yards. Parts of the radar antenna were found buried four feet in the ground at the point of impact.

ENCLOSURE 8c TO VME(N)54 AAR SEC 3-53 OF 1 MARCH 1953  
IMPACT POINT AND DECEASE

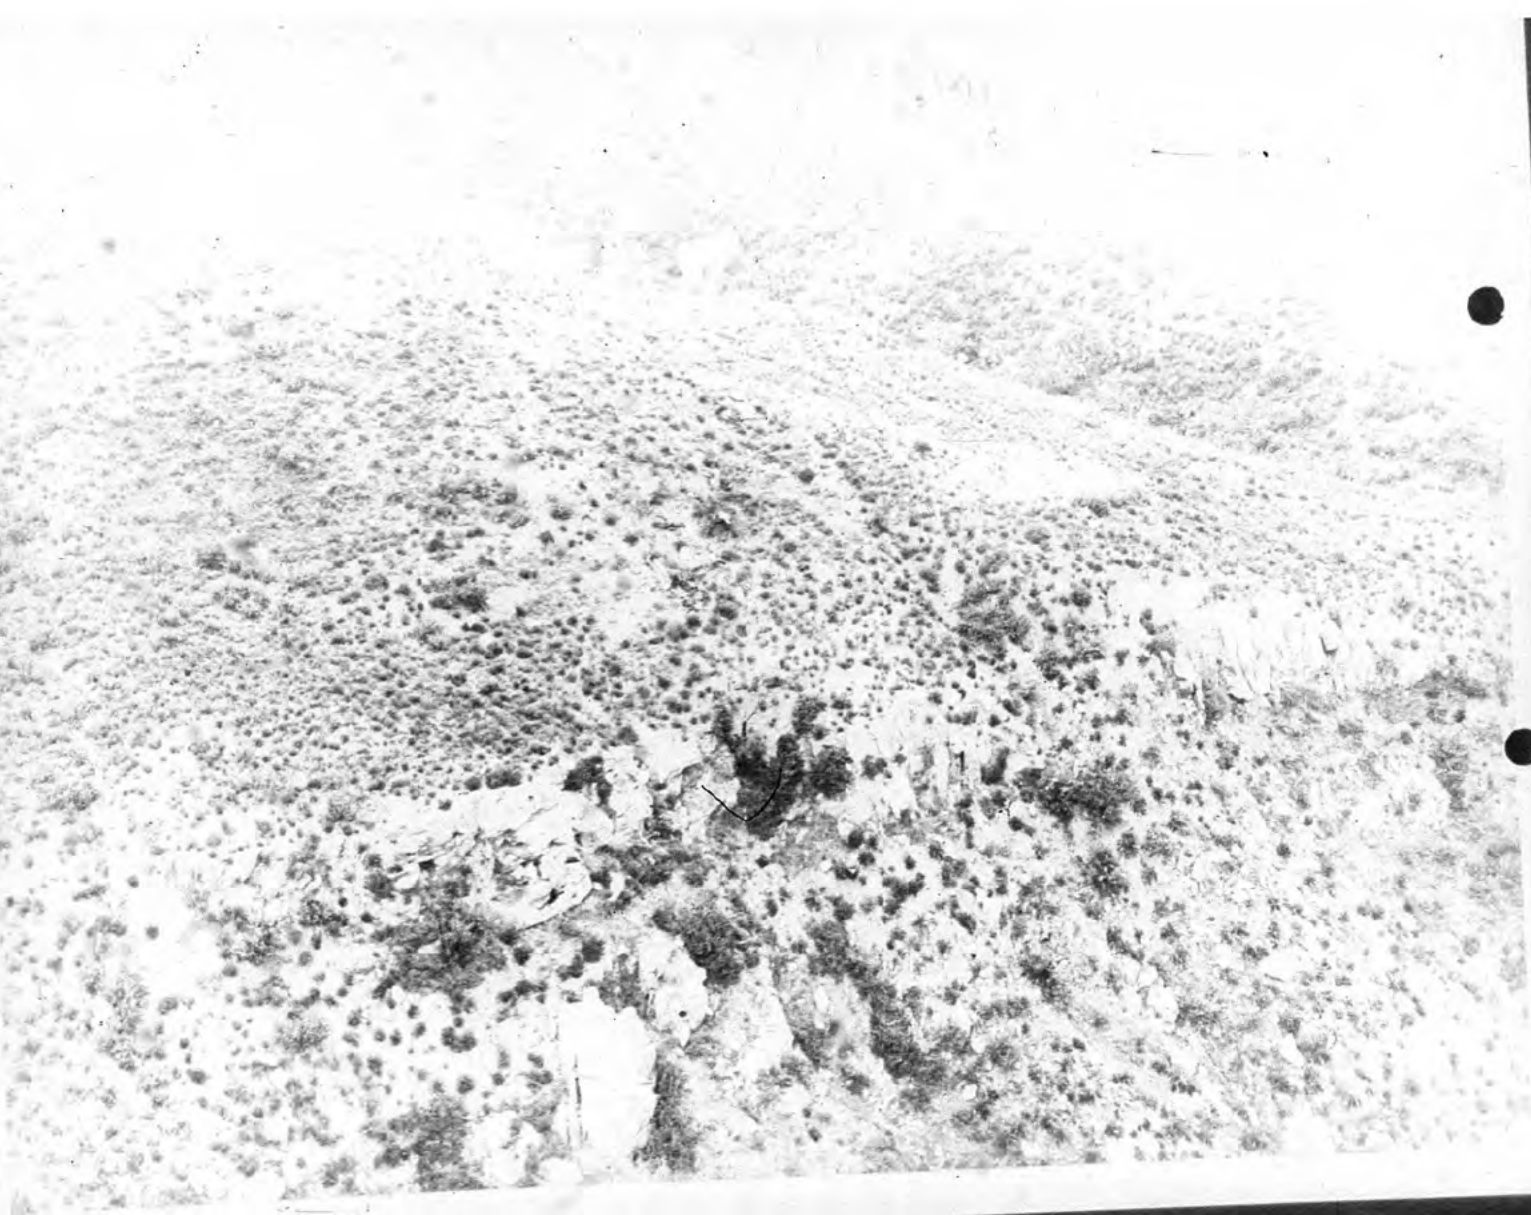
WH-2 was found the next morning at approximately 33° 50' N-117° 40' W. The aircraft and bodies were demolished. Wreckage was found on the opposite side of the ridge line from the point of impact. A line from the point of impact to the wreckage on the opposite side of the ridge indicated that the direction of flight before impact was approximately 130° magnetic.

ENCLOSURE #4 TO VME (M) 592 AAR 503 3-50 OF 4 MARKS  
IMPACT POINT

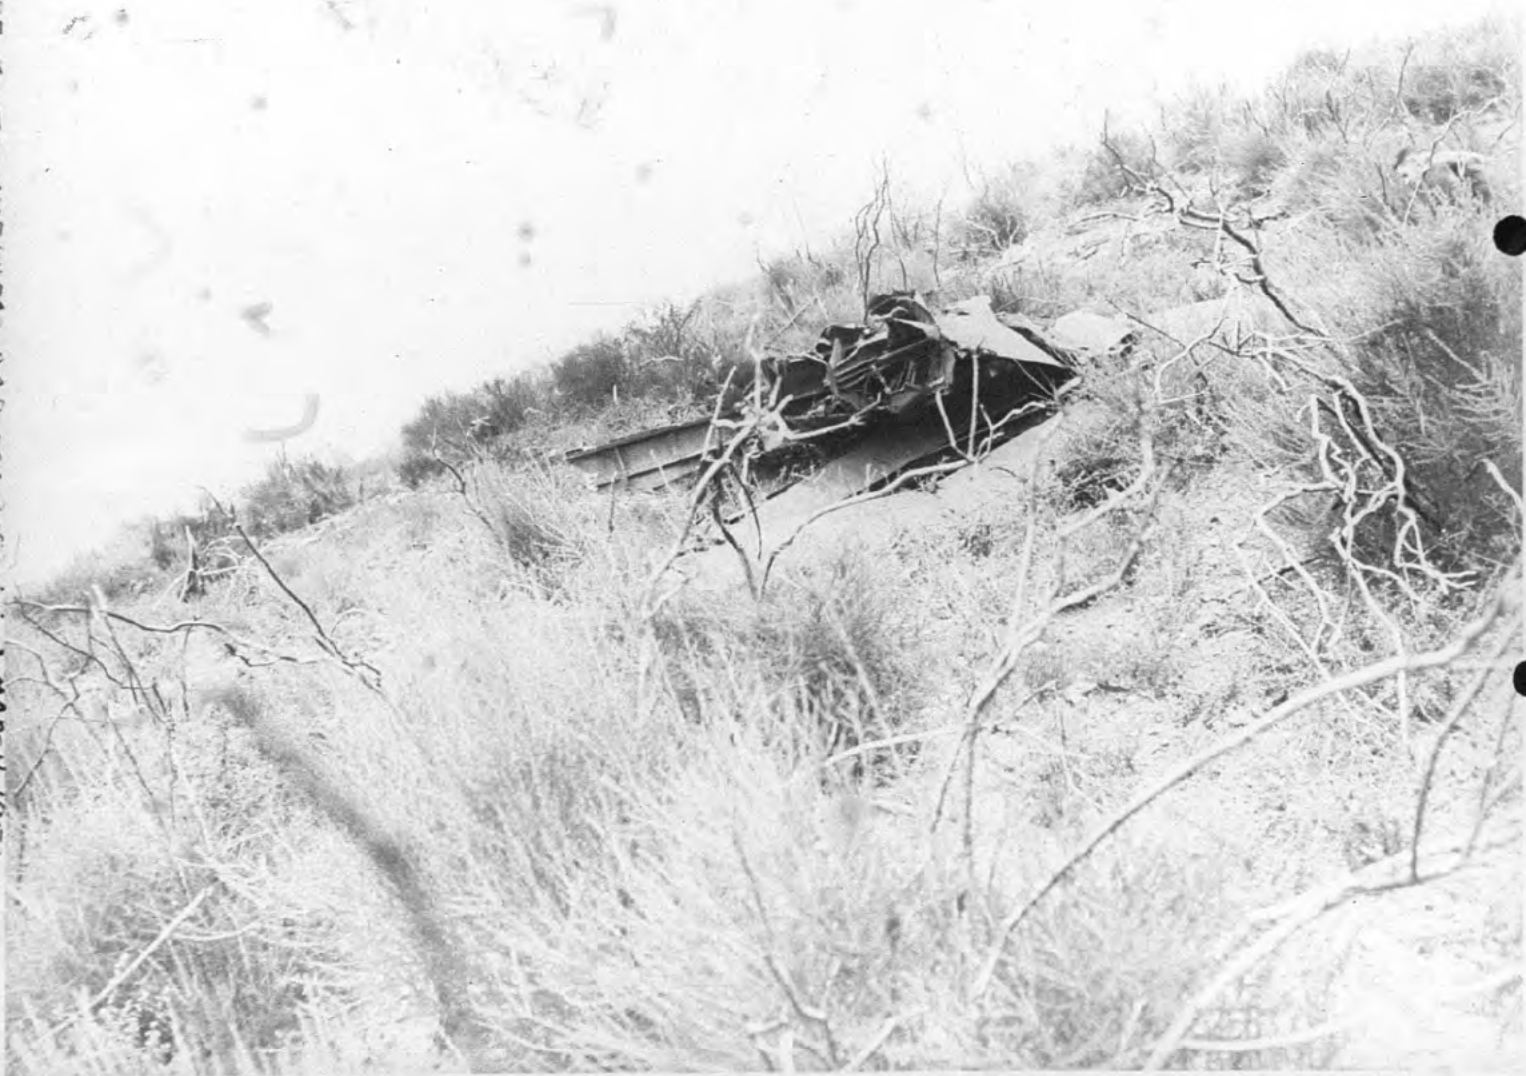
ENCLOSURE XC TO VMF(N)542 AAR SCV 3-53  
BURNED FUELAGE SE (N) ? MARCH 1953

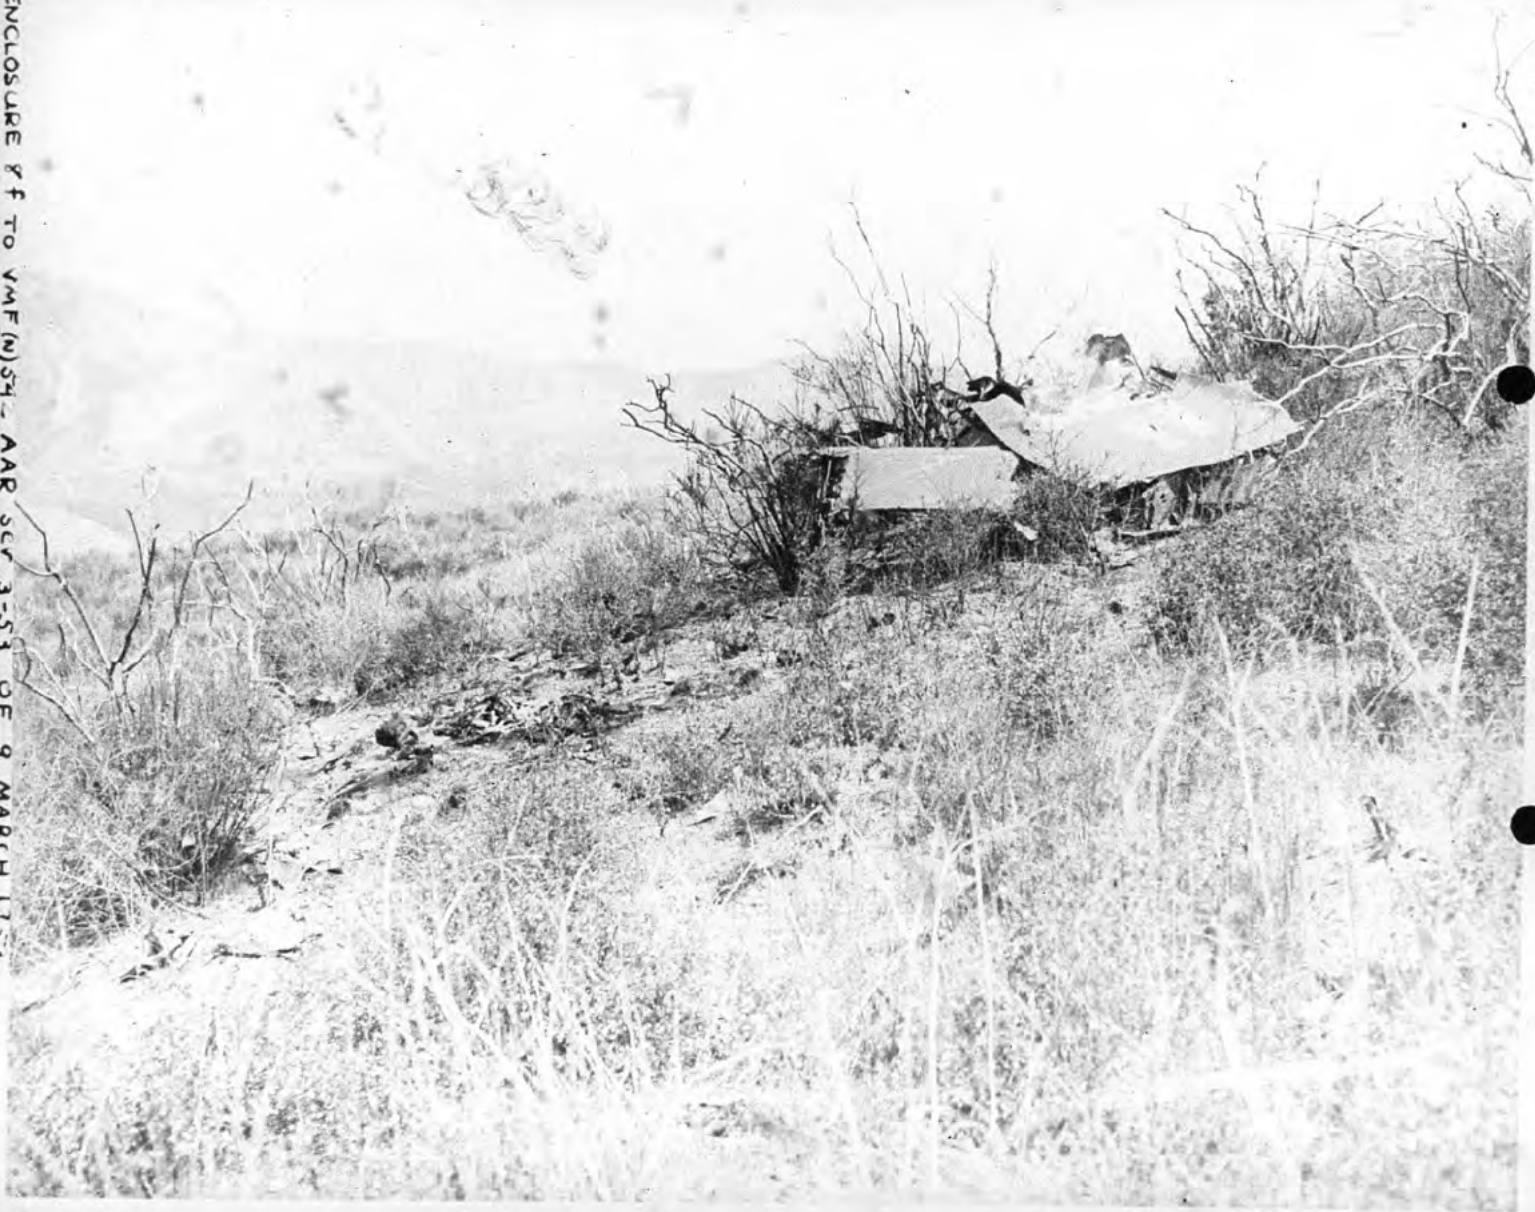
ENCLOSURE 8 f TO VMF(N)54 - AAR 307 3-53 OF 9 MARCH 1953  
BURNED WING FUSelage SECTION
